Attachment D. Visual Simulations

Viewpoint Information

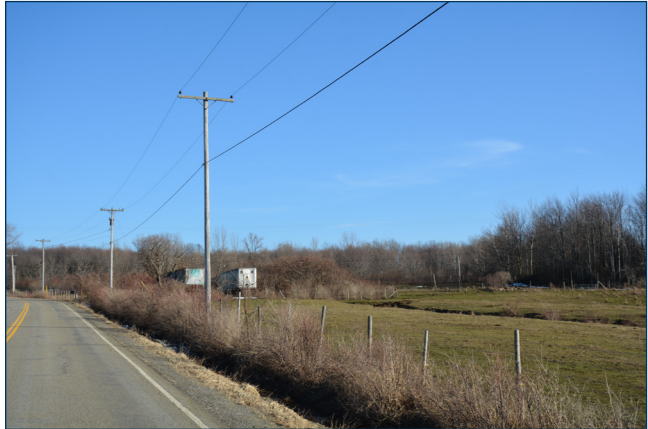
Existing View

Existing Condition

Viewpoint 63SE is located approximately 240 feet from the collection substation and 600 feet from the point of interconnection (POI) switchyard. It is the same location as Viewpoint 63S on County Route 6, but the view is oriented to the southeast rather than the south. The existing view in this direction features the surface of County Route 6 on the left, extending from the immediate foreground into the middle ground. The roadway is lined on the right by a roadside ditch, a band of unmanaged vegetation, an overhead utility line, and agricultural fencing. These linear features draw the viewer’s attention down the roadway toward two large semi-trailers situated behind the fencing. The foreground to the right of the roadway features a fenced pasture. The trailers and pasture are backed by a band of dense deciduous vegetation that blocks views of more distant landscape features. The view has relatively low scenic quality due to its enclosed character, level topography, lack of interesting focal points, and presence of the existing trailers.

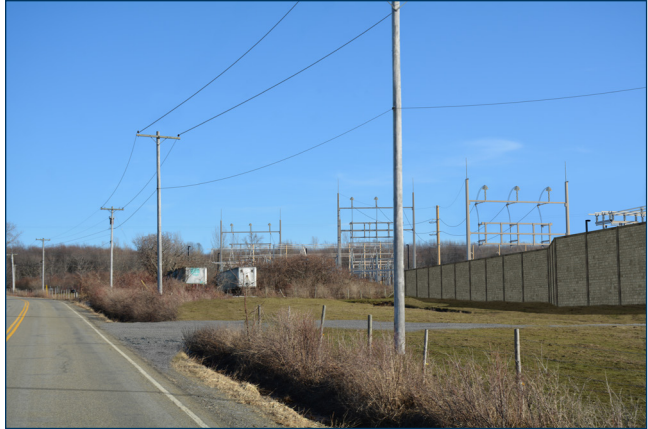
Proposed View

With the proposed Facility in place, the proposed collection substation is situated to the right of the view in the foreground, and the POI switchyard is situated in the center of the view in the middle ground, partially obscured by the existing trailers and woody vegetation. The sound barrier wall associated with the collection substation appears as a long, rectangular box on the left side of the view in the foreground. The solid massing presented by the wall screens views of the forest and vegetation behind it. The stations appear large and visually complex. Several new man-made structures, including overhead gantry structures, transmission poles, lighting poles, and substation components, extend into the sky and present significant contrast with existing features of the landscape in line, color, texture, and form. The stations add significant visual clutter to the view and become the dominant character defining feature of the landscape. Because the stations, particularly the POI switchyard, are semi-transparent, views of the forest and existing transmission line behind it are still available. However, the forest is clearly subordinate to the utility infrastructure that now dominates the view. While introducing new built elements and a contrast in texture, the stations have lines and colors similar to the existing fence posts, utility poles, and background vegetation present in the view. Although these new structures add substantial utility infrastructure to the view, their setback from the road, partial screening, and the presence of existing built/man-made feature somewhat limit their dominance and visual impact.

Component	Score		Contrast Rating 5-7 Years
	Install	5-7 Years	
Landform	2.0	1.8	Moderate
Vegetation	3.0	2.6	Moderate/Appreciable
Land Use	2.6	2.3	Moderate/Appreciable
Water	NA	NA	NA
Sky	3.4	3.1	Appreciable
Viewer Activity	3.3	2.9	Appreciable
AVERAGE	2.9	2.5	Moderate/Appreciable

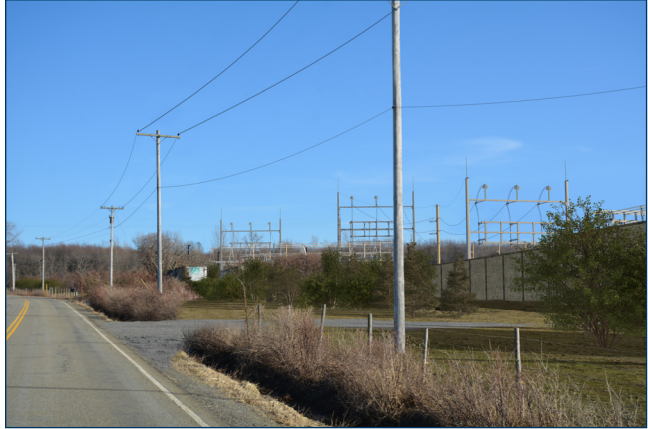
View with Mitigation

Landscape Mitigation

With proposed mitigation plantings in place, and following five to seven years of growth, the visual mass of the collector substation sound barrier wall is softened, yet still strongly visible. The plantings provide some screening of the lower portions of the substations, while the high contrast upper portions are unscreened and continue to draw viewer attention. With additional growth, taller trees will provide additional softening of the lower portions of the substation and will help to blend with the existing background vegetation. However, the upper portions of the tall, vertical gantry structures are likely to remain unscreened and present visual contrast with the background vegetation. Although the presence of conifers in the plantings is not consistent with the existing forest vegetation, it enhances screening during the dormant season and will be less noticeable during the growing season.

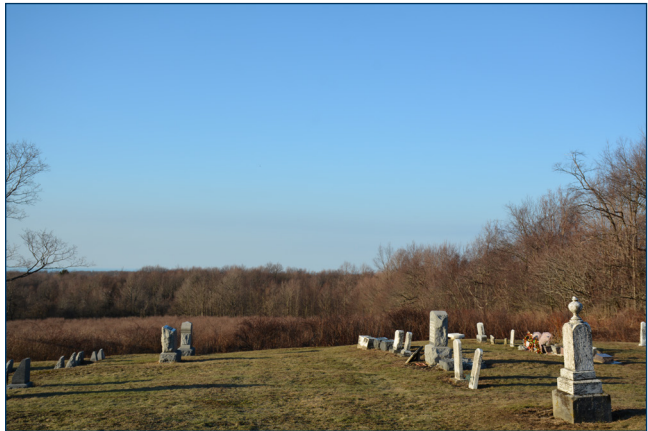
Existing View

Existing Condition

Viewpoint 69 is located at the South Ripley Cemetery off County Route 6, approximately 411 feet from the nearest proposed PV panel array. This viewpoint is in the central portion of the Facility Site and is representative of views available to visitors from the cemetery’s interior. The existing view to the north from this location features a mowed lawn and rows of headstones within the cemetery which draw the viewer’s eye to the foreground. The edge of the cemetery is defined by a band of brushy vegetation that extends into an overgrown open field to the north. Beyond this low brushy vegetation, the view is enclosed by mature deciduous trees in the middle ground that wrap around the edges of the field and border the cemetery to the east. An expanse of clear blue sky overhead gives the view a feeling of openness and adds to the layering of distinct horizontal bands of color in this view. Other than the headstones in the cemetery, the view lacks evidence of development and has a secluded and peaceful feel. Scenic quality is moderate to high.

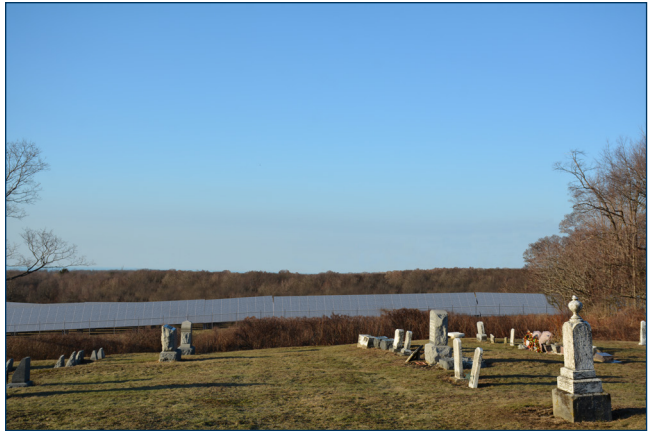
Proposed View

With the proposed Facility in place, the overgrown field in the middle ground is now occupied by a large mass of solar panels that become a dominant feature of the view. Because the panels are facing the viewer, their surface reflects the blue color of the sky and individual rows are difficult to discern. Presence of the panels appears to flatten the topography and presents line, texture, color, and form contrast with the existing vegetation. The panels are compatible with the existing horizontal layering up the landscape, and tree clearing to accommodate the panels makes the former field wider, which maintains a sense of open space. However, the panels represent a significant change in land use and present strong contrast with the peaceful rural character of the cemetery.

Component	Score		Contrast Rating 5-7 Years
	Install	5-7 Years	
Landform	2.5	2.1	Moderate
Vegetation	3.3	2.5	Moderate/Appreciable
Land Use	3.8	3.5	Appreciable/Strong
Water	NA	NA	NA
Sky	1.1	1.1	Minimal
Viewer Activity	3.8	3.4	Appreciable/Strong
AVERAGE	2.9	2.5	Moderate/Appreciable

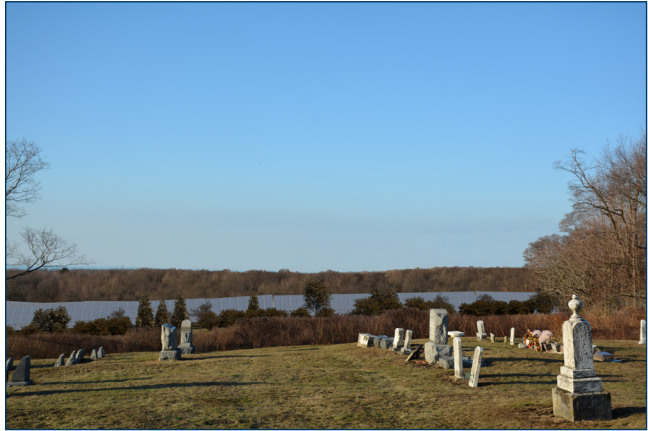
View with Mitigation

Landscape Mitigation

With proposed mitigation plantings in place, the harsh horizontal line of the panel array is interrupted, and the array partially screened. However, most of the array remains visible and continues to present appreciable contrast with the existing landscape and land use. The screening and softening effect of the plantings would be greater if they were installed closer to the edge of the cemetery. However, in doing so, the sense of openness in this view would be reduced. Increased enclosure of the view and more complete separation of the two distinctly different land uses could be beneficial at this location.
