South Ripley Solar Project Town of Ripley, Chautauqua County, New York EDR Project No: 19020

Viewpoint 59

County Route 6 (NE Sherman Road) - NEW

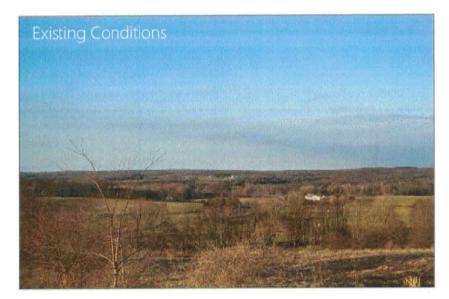
Viewpoint Number: 75

THE LEAFON CONDITION WILL CHANGE THE NEW AND CONCEAL MORE ELEMENTS, INCLUDING

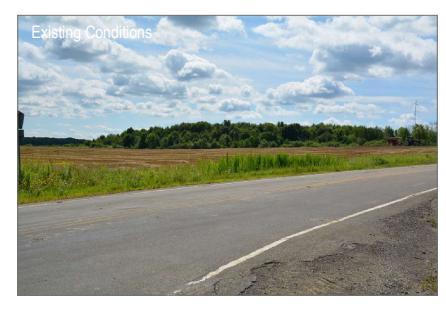
Viewer Description: (Please describe this view in your own words.) Open view of an ag. field mid. ground, with a road and drainage area in the foreground, and dense trees/ shrubs in the background. A mature deciduous treeline is visible along the horizon. Views of open space over the ag. use are dominant from this angle. The composition is composed of several horizontal lines rather than a singular focal point; the sky, the deciduous treeline, and the brown ag. field / drainage and the road. Viewer appears level with project site. Tall wind structure noted on the right side of view. Partially cloudy sky observed

The relatively medium height of the volunteer plantings in the drainage area effects the rating of this view - bottom of array appears less impactful than if these plantings were cut down. The leaf-on condition of the trees in the forest in the background makes the skyline appear more dramatically altered in the sim. view conditions.

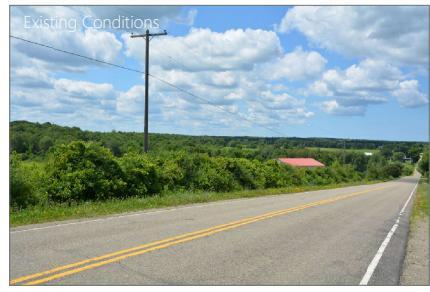
Effectiveness of mitigation planting scheme (seasonal/variability, etc.): Mitigation planting screen appears to partially obscure the visible parts of the array but not entirely. The mitigation plantings visually blend nicely into the existing shrub hedge that is partially obscuring the array view. The seasonal color that is noted in the mitigation plantings contrasts with the existing color and texture of the vegetated scene.

The foreground shrub hedge row that is obscuring mid. ground view appears lush and un-maintained. The leaf-on condition at the time of this photo adds to the overall screening effectiveness and dense green texture in the foreground and forested background.

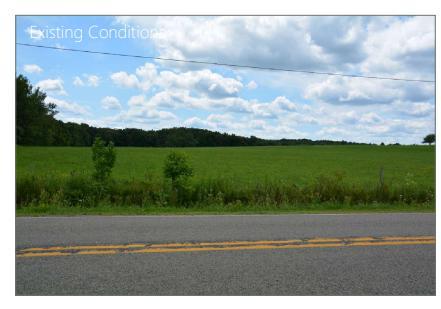
The low height of the volunteer plantings in the drainage area effects the rating of this view. The leaf-on condition of the trees in the forested background makes the skyline appear in greater contrast in the sim. view conditions. The low cut of the grassland vegetation makes the mitigation plantings appear in greater contrast to existing conditions.

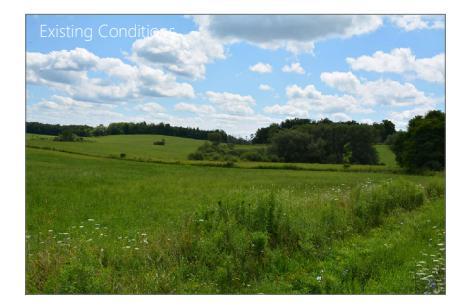
Viewpoint Information: Viewpoint Number: 20

Viewer Description: (Please describe this view in your own words.) Expansive view of numerous rolling grasslands with layers of shrub and forested areas in the background that creates a mosaic effect and adds to the feeling of openness. A drainage area is noted in the foreground. Grassland vegetation height is not continuous between foreground and mid. ground, giving the sense we are viewing across multiple properties. Islands of thick tree and shrub vegetation with grassland surrounding in the mid. ground. Dense forested island at the center of the view acts as a focal point. Partially cloudy sky.

The tall volunteer planting in the drainage area helps to blend mitigation plants into the existing view. The leaf-on condition of the forest/ tree line provides a strong visual contrast against the rolling grassland in the foreground. A leaf-off condition might greater emphasize the change in skyline geometry. The grassland in the foreground is relatively low and this variable may alter the visibility of project components on the left side of the view.

The loss of sight distance and land use change are notable. Mitigation plantings in the 5-7 year view create a semi-continuous visual buffer to the project components beyond. This perceived border of vegetation in the foreground softens the impact of the visual changes however, many of the changing parameters noted will negatively impact the viewer's enjoyment.

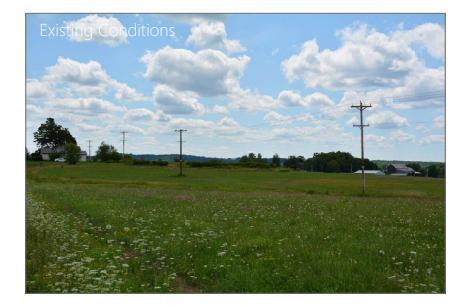
The grasslands in the foreground have wildflowers and was left to grow a medium height. The rating was heavily influenced by the stark contrast between the light foreground and the dark array field. Similarly, in the background deciduous forest, the leaf-on condition and the highlights from the sun provided great contrast to the proposed dark horizontal line.

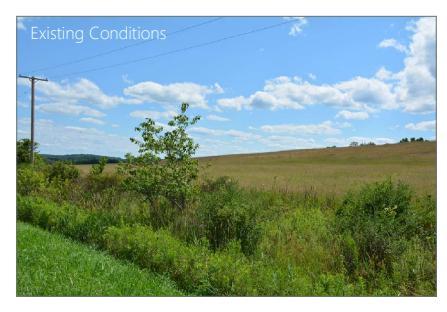
The various heights of the grasslands in the view create a strong compositional relationship with the skyline geometry that is obscured in the sim. views. The leaf-on condition and the height of the shrub hedge to remain greatly impacts the effectiveness of the mitigation plantings.

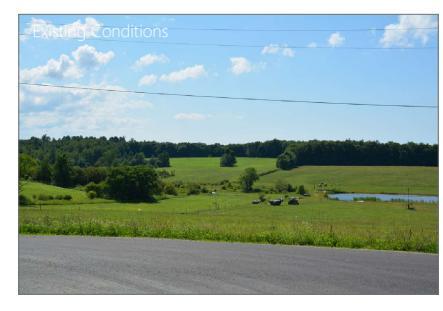
The height and bright green color of the grass gives the existing view a very scenic quality that contrasts highly with the array field and mitigation plantings in the sim. views. The bright sky and leaf-on condition of the forested background also contributes to this contrast.

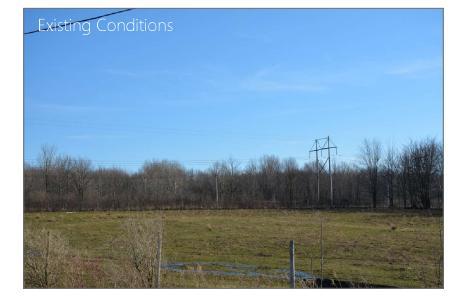
Viewpoint Information: Viewpoint Number: 59

Viewer Description: (Please describe this view in your own words.) A somewhat open grassland mid. ground with dense deciduous forest in the background. Large overhead utility structures noted in the mid. ground that interrupt an otherwise continuous skyline geometry created by the forest edge. The foreground has a natural wood staked, metal fence and a few sparse woody shrubs. The topography of the site is minimal but does appear to slope towards the viewer. Deciduous vegetation appears in leaf-off condition. The edge of the low grassland field is a strong horizontal line in the view. The sky is clear and sunny.

Effectiveness of mitigation planting scheme (seasonal/variability, etc.): Mitigation plantings only partially screen project components. Plantings appear lush and green, this contrasts with the leaf-off deciduous plantings beyond. Most of the project components extend above the plantings and create strong contrast against the blue sky. Plantings appear as several massings with a break in the middle of the view that reveals the components beyond. The massing appear somewhat naturalized and parallel the existing fence and road, similar to a tree lines found along property lines in this land use type.

The existing vegetation appears to be deciduous and in a leaf-off condition. This contrasts greatly with the

of the photo. This condition probably creates more contrast in the change in skyline geometry.

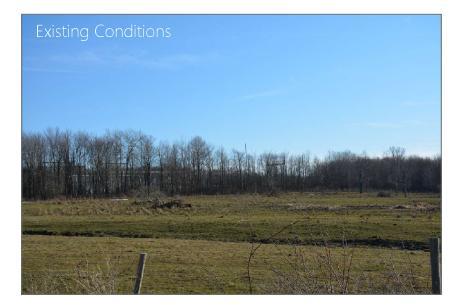
The existing vegetation appears to be deciduous and in a leaf-off condition. This contrasts greatly with the mitigation plantings and emphasizes the contrast in skyline geometry. Sky was clear and pale blue at the time of the photo. This condition probably creates more contrast in the change in skyline geometry. Grass appears low / maintained in both the existing and proposed views.

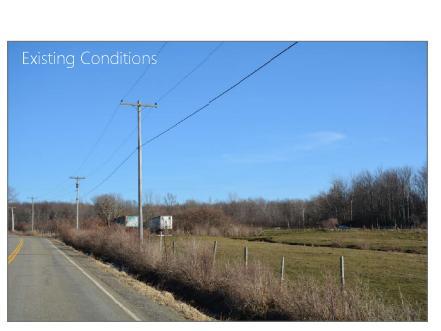
The existing vegetation appears to be deciduous and in a leaf-off condition. This contrasts greatly with the

of the photo. This condition probably creates more contrast in the change in skyline geometry. Grass is a

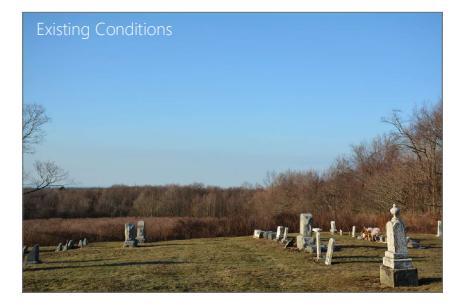
Viewer Description: (Please describe this view in your own words.) Semi-open lawn and cemetery in foreground. Numerous headstones aligned with viewer's sight-line. Some deciduous trees noted on the left edge of the view. Mid. ground tall grass / shrub /scrub have a consistent red-brown coloration.

The leaf-off condition of the deciduous forest creates a high contrast with the mitigation plantings. The height of the scrub greatly influences the effectiveness of the screening and overall impact of the project components. The clear sky matches in color the project components and minimizes the contrast with the existing scene.

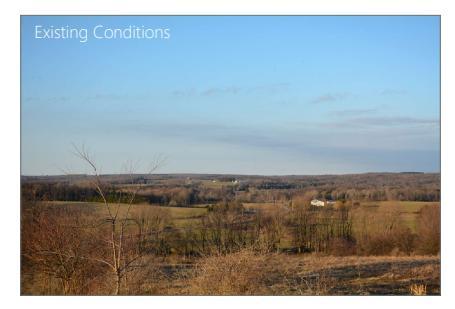
Viewer Description: (Please describe this view in your own words.) Open scene where viewer's sight line travels a long distance across numerous land uses and vegetation types. Foreground is grassland w/ sparse woody shrubs and trees. In the mid. ground; a horizontal treeline, sprawling lawn/ grassland with a road bisecting it, islands of dense tree coverage in the center of the view, and residences on the right side of the view. The background is mostly deciduous forest coverage with grassy lots, and ag. building/ residences layered in the center of the image. Topography is gently rolling hills with a continuous skyline geometry against a partially cloud sky.

Sim. photo taken during leaf-off conditions. Foliage may better screen project components. The level of reflectivity of project components may change the level of scenic difference. Array field are rendered very dark in this view which blends into the shadowed areas of forest cover.

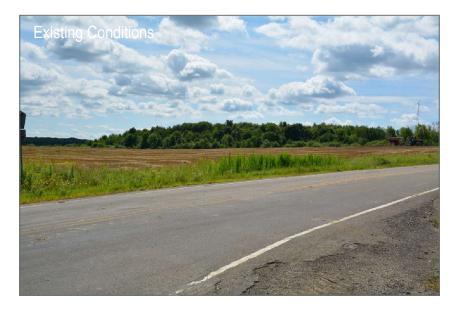
The bright blue sky contrasts significantly with the panels creating a hard line. If the sky were an overcast cloudy day it may have influenced the rating. The mitigation efforts help break up the form of the panels. Seasonal "leaf-off" conditions for the deciduous mitigation would have influenced my rating.

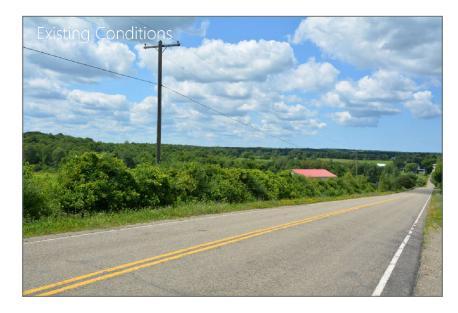
"Leaf off" conditions would have influenced my rating given more visibility of the solar panels. Seasonal color may have influenced the rating creating more contrasting colors_ against the dark panels.

Minimal/insignificant impact to the viewer during "leaf out" conditions. The panels are screened by the existing road side vegetation and the proposed mitigation helps create a texture that softens the hard lines/edge of the panels in the middle ground.

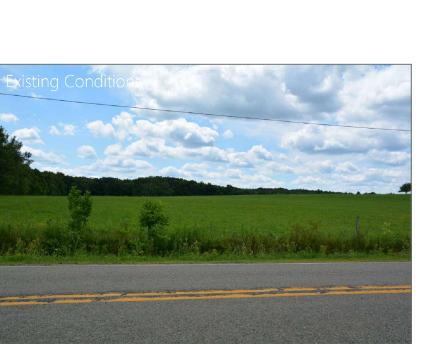
shrubs and evergreens to help screen the view the panels. The plan would recommend benefit from recreating a

"Leaf off" conditions would have influenced my rating given more visibility of the solar panels. The panels are less

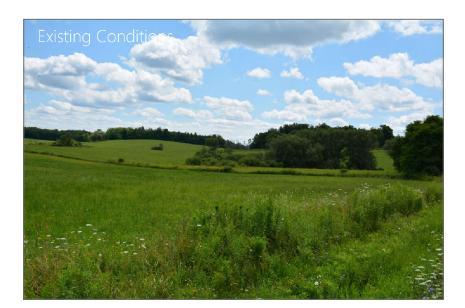
Viewpoint Information: Viewpoint Number: 20

"Leaf off", non growing season and winter conditions would have influenced my rating creating more contrast between

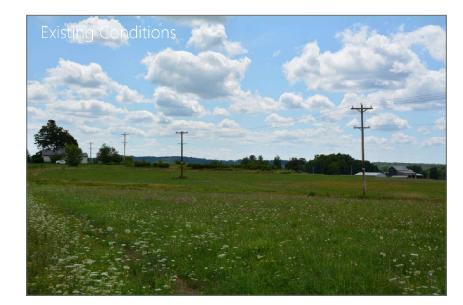
Lighting conditions during the time of day this view was taken. The partly cloudy sky appears to cast shadows on the

trees in the middle ground appearing darker than they truly are. Leaf off conditions and seasonal weather (snow,

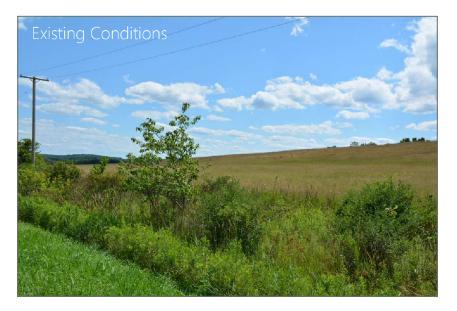
Viewer Description: (Please describe this view in your own words.) Open view from road side edge. Existing lawn shoulder along road before transitioning to roadside vegetation. A golden agricultural field rises in the middle ground to create a horizon against the blue sky in the center of the image. The existing roadside vegetation creates a focal point as it breaks ups the horizon from mature trees on the left in the far distance to golden agricultural fields. An existing utility pole can be seen with overhead wires. The topography has dramatic rise in elevation from left to right in this view.

Leaf off conditions and seasonal weather (snow, golden fields, etc) would have

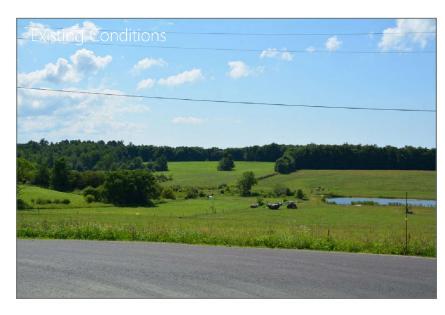
Viewer Description: (Please describe this view in your own words.) Gravel road in the foreground. Rolling green farm fields with a pond, farm equipment, fence and cattle in the middle ground. Existing power lines contrast against the blue sky. Mature trees create a strong contrasting horizon in the middle ground. Existing hedgerows also can be seen creating linear vegetation within the view. The topography appears to be gentle and sloping away from the gravel road then up to the horizon.

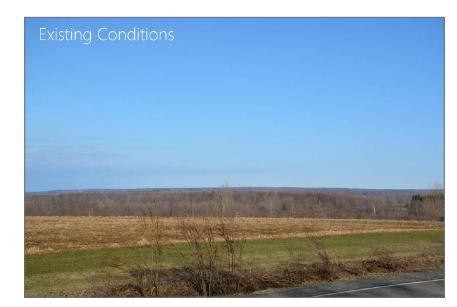
Viewpoint 56 County Route 6 (NE Sherman Road)

Viewer Description: (Please describe this view in your own words.) Open view from an existing road. The trees are not in leaf and view is dominated by the blue sky and even horizon. Appears to be mown lawn area between the golden agricultural fields and mature trees in the middle ground. There are power lines in the middle ground but they blend in with the mature trees in the middle ground.

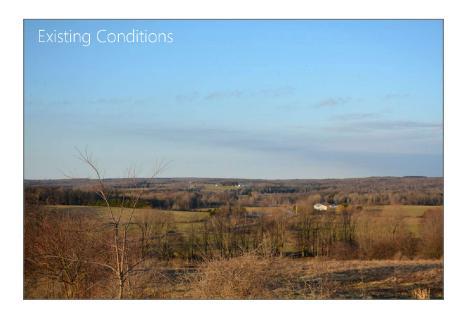
Viewer Description: (Please describe this view in your own words.)
<u>The foreground has an existing agricultural field buffered</u>
by roadside vegetation. The trees are not in leaf. The landscape
is visually broken up by a road traversing in the middle
ground, buildings and agricultural fields scattered throughout
the middle ground and power poles can be seen along the
road and a body of water (pond) in the center of the view.
Mature trees define the horizon. The topography appears to be
gently rolling hills.
